DAILY INSPECTION REPORT

REPORT #SWI003 OAK CREEK 150K TANK 3 - 20230424-6, APPROVED OAK CREEK 150K TANK 3, OAK CREEK, ARIZONA, UNITED STATES

Description of Items and/or Areas of Work: Exterior

coating inspection

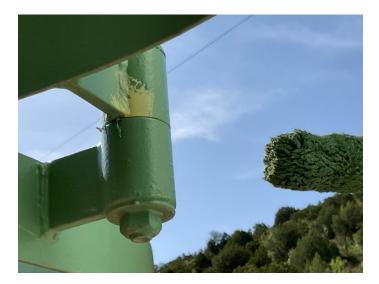
Missed area of top coat

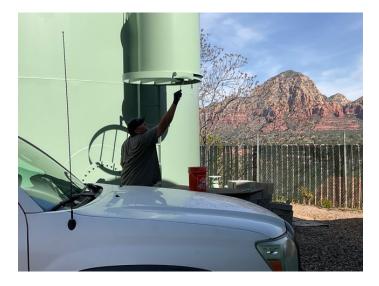
Missed area of top coat

Coating repairs in process

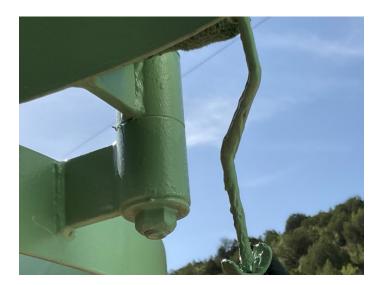
Completed coating repair
