DAILY INSPECTION REPORT

REPORT #SWI003 OAK CREEK 150K TANK 3 - 20230424-6, APPROVED OAK CREEK 150K TANK 3, OAK CREEK, ARIZONA, UNITED STATES

Description of Items and/or Areas of Work: Exterior

coating inspection

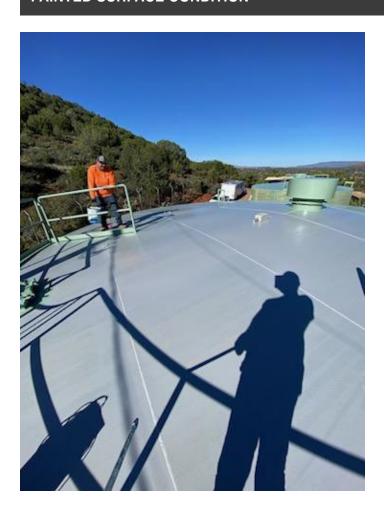
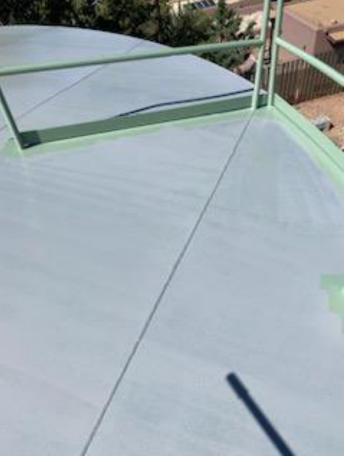
Exterior Roof (3) - Prime tie-coat PPG Amerlock 2

Exterior Roof (3) - Prime tie-coat PPG Amerlock 2
Photos supplied by STS

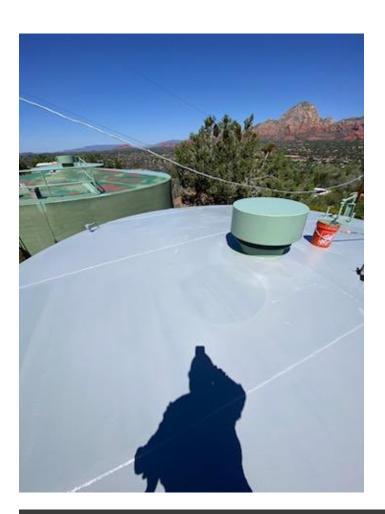
Exterior Roof (3) - Prime tie-coat PPG Amerlock 2
Photos supplied by STS

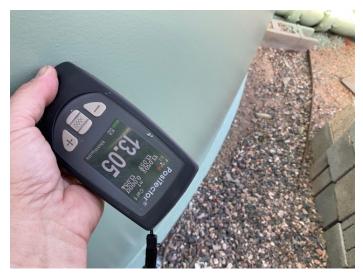
60K East Tank - Dry Film Thickness Measurement DeFelsko Positector 6000

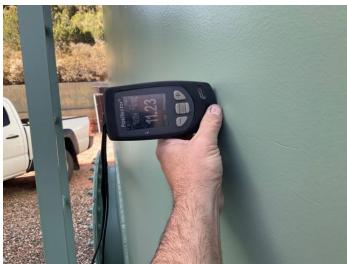
60K East Tank - Dry Film Thickness Measurement DeFelsko Positector 6000

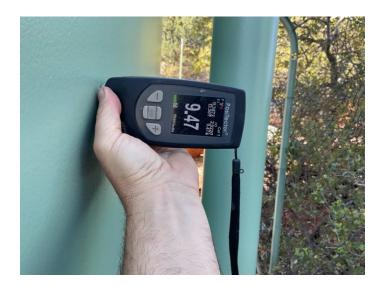
60K East Tank - Dry Film Thickness Measurement

DeFelsko Positector 6000

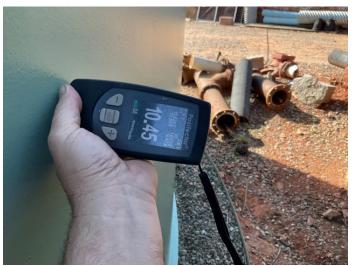
60K East Tank - Dry Film Thickness Measurement
DeFelsko Positector 6000

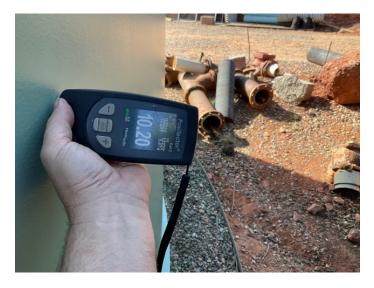
60K East Tank - Dry Film Thickness Measurement

DeFelsko Positector 6000

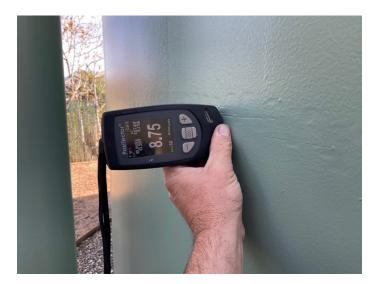
60K East Tank - Dry Film Thickness Measurement

DeFelsko Positector 6000

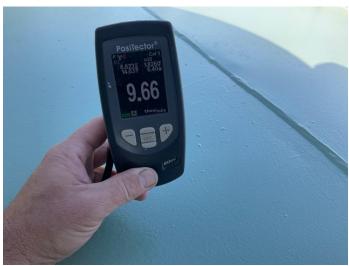
60K East Tank - Dry Film Thickness Measurement
DeFelsko Positector 6000

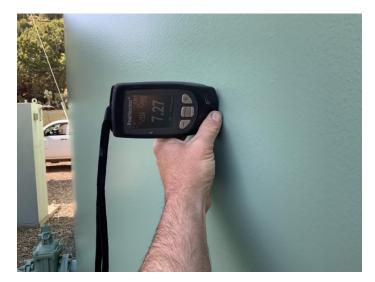
150K Tank - Dry Film Thickness Measurement DeFelsko Positector 6000

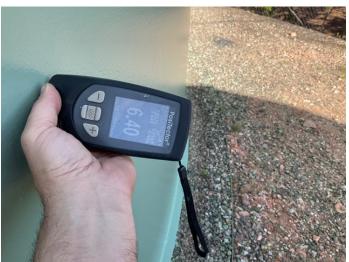
150K Tank - Dry Film Thickness Measurement DeFelsko Positector 6000

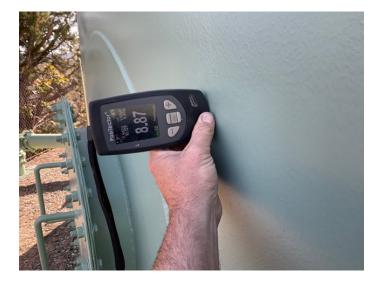
150K Tank - Dry Film Thickness Measurement DeFelsko Positector 6000

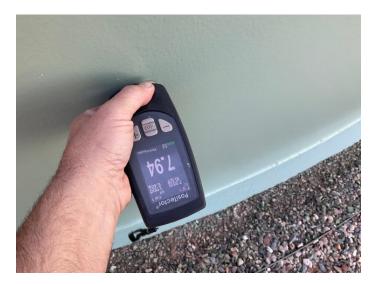
150K Tank - Dry Film Thickness Measurement DeFelsko Positector 6000

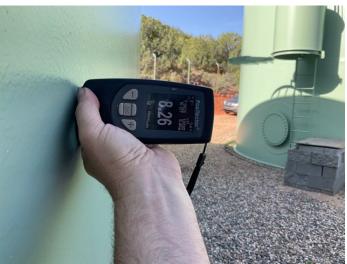
150K Tank - Dry Film Thickness Measurement DeFelsko Positector 6000

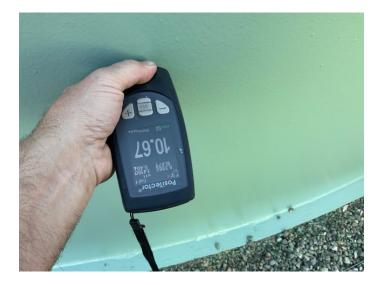
150K Tank - Dry Film Thickness Measurement DeFelsko Positector 6000

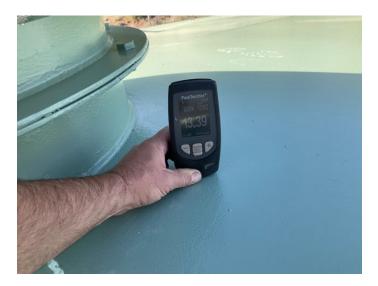
150K Tank - Dry Film Thickness Measurement
DeFelsko Positector 6000

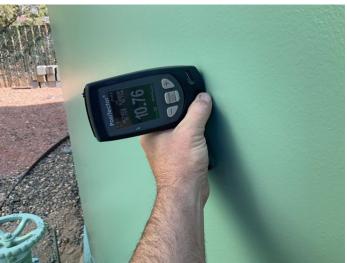
60K West Tank - Dry Film Thickness Measurement

DeFelsko Positector 6000

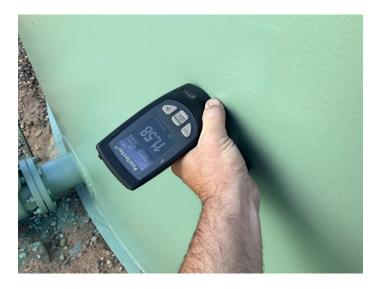
60K West Tank - Dry Film Thickness Measurement

DeFelsko Positector 6000

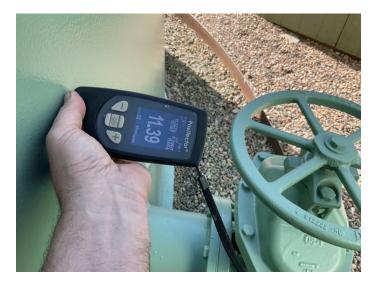
60K West Tank - Dry Film Thickness Measurement DeFelsko Positector 6000

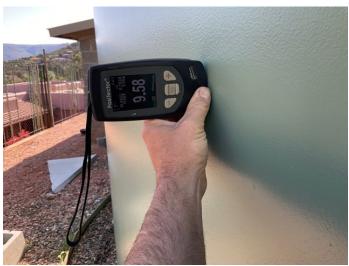
60K West Tank - Dry Film Thickness Measurement DeFelsko Positector 6000

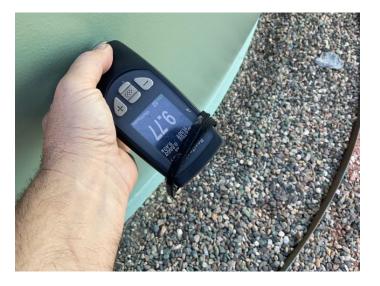
60K West Tank - Dry Film Thickness Measurement DeFelsko Positector 6000

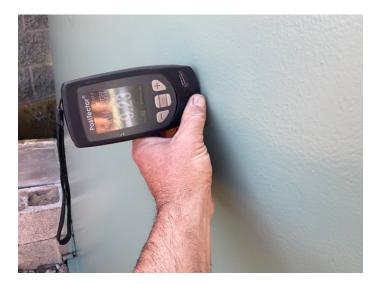
60K West Tank - Dry Film Thickness Measurement

DeFelsko Positector 6000

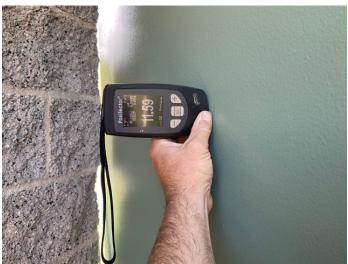
60K West Tank - Dry Film Thickness Measurement

DeFelsko Positector 6000

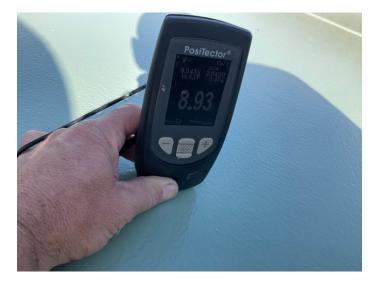
60K West Tank - Dry Film Thickness Measurement

DeFelsko Positector 6000

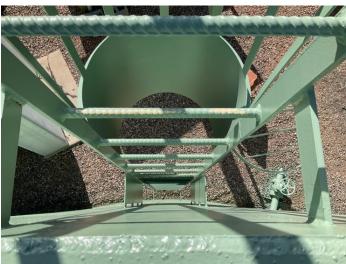
Missed area of top coat
